MSHA's Accident Prevention Program Safety Tip

Shrapnel From Miners' Bits

Category : Longwalls and Section Face Equipment
Mine Type: All Underground

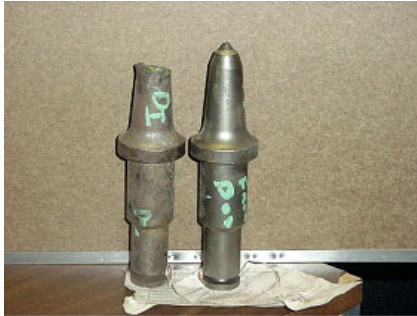
A continuous mining machine operator was fatally injured when a piece of shrapnel from a miner bit flew back from the face. A sharp, lethal piece of steel, traveling at a high speed struck him in the neck.

Hard carbonate nodules had been encountered in the cut resulting in a large amount of sparking at the face. The accident investigation revealed the shrapnel came from a miner bit which had lost its tungsten carbide cutting tip.

- Replace dull, cracked or burred miner bits every cut and more often when hard cutting conditions are encountered. When in doubt follow the bit manufacturers' replacement recommendations. Once the tip is lost the bit body becomes a blunt pick pounding on the face.
- Wear appropriate personal protective equipment such as ANSI Z87.1 eye and face protection when near the active mining face.
- Read, know and follow manufacturers' recommendations and company safety policy.
